eGalaxTouchManager

Auto Tuning Quick Guide

For EXC31xx Series

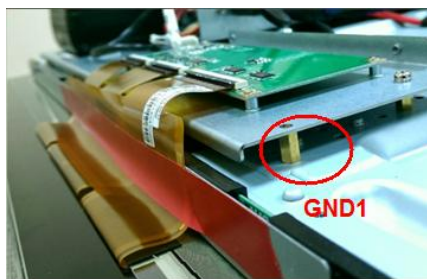
Figure 1-2. GND1 (GND of case)

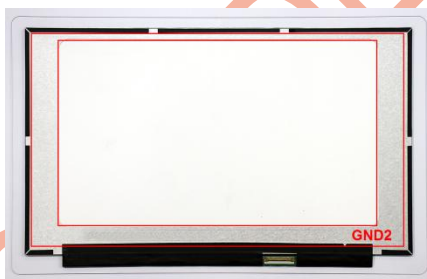
Figure 1-3. GND2 (GND of LCD panel)

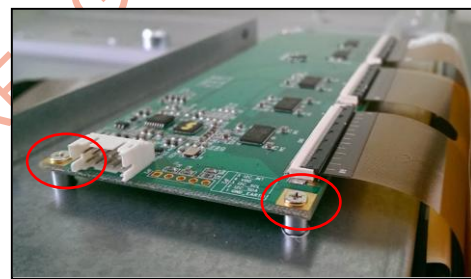
Figure 1-4. GND3 (GND of Touch Controller)

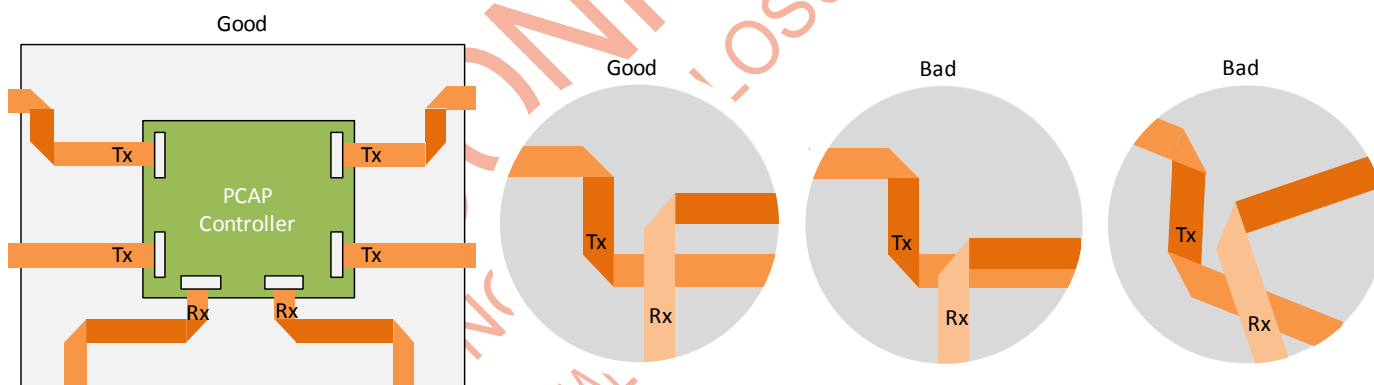
Please arrange Tx/ Rx FPC tail tidy, if it is intended to overlap Tx/ Rx tail by some mechanical / interference purpose, please overlap them in a right angle, other angle may cause signal interference between Tx and Rx FPC tail.

Figure 1-6. Tx/ Rx FPC tail overlap condition.

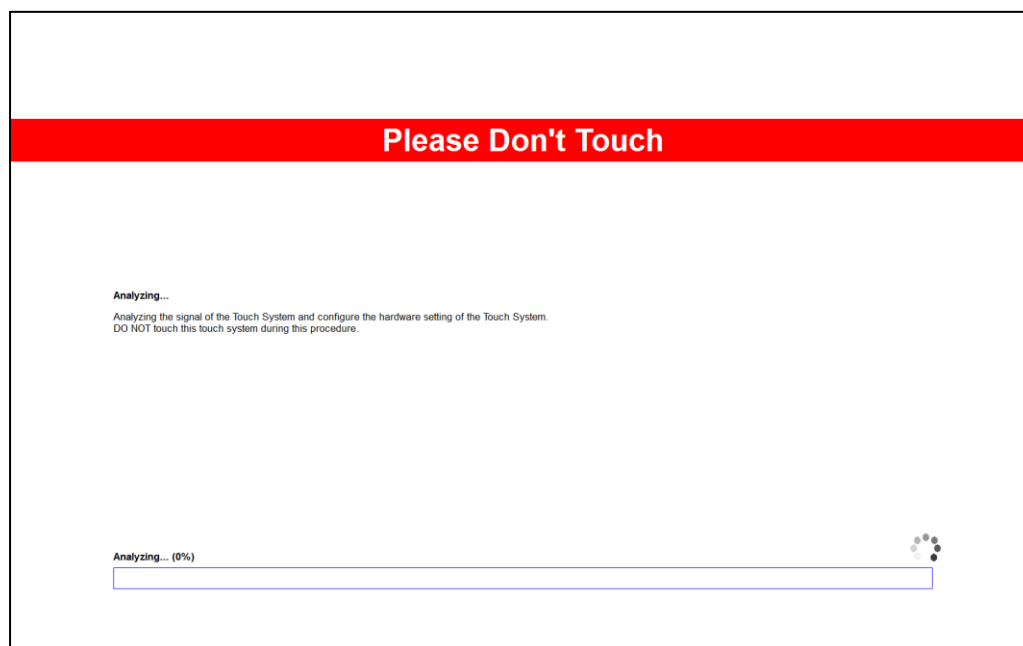
2.7 Save Calibration Data

(Warning) !!!! Do not touch the screen or put any conductive item on the screen !!!

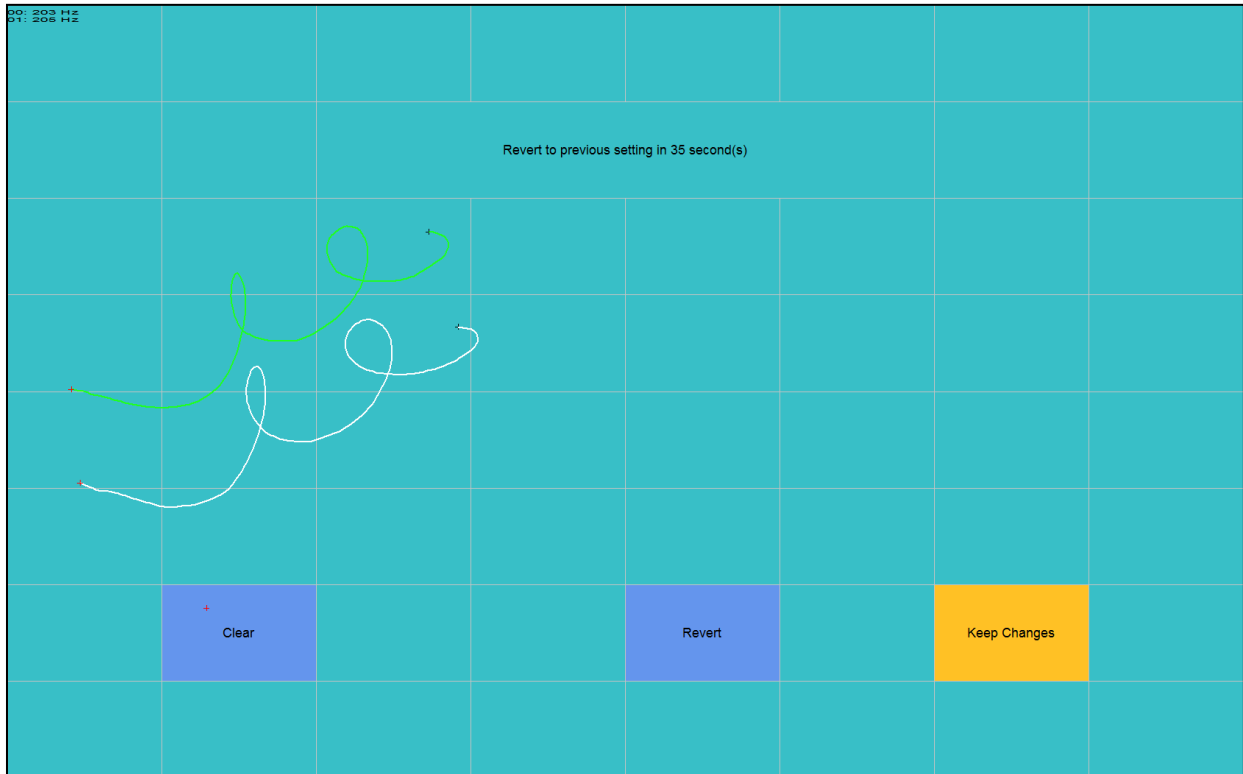
2.8 Touch Performance Validation

“Keep Changes”: Keep the tuning result

“Revert”: Ignore tuning result and revert back to the previous parameters.

(Warning) If “Keep Changes” button is not clicked in 40 sec, TouchManager will automatically “Revert”.

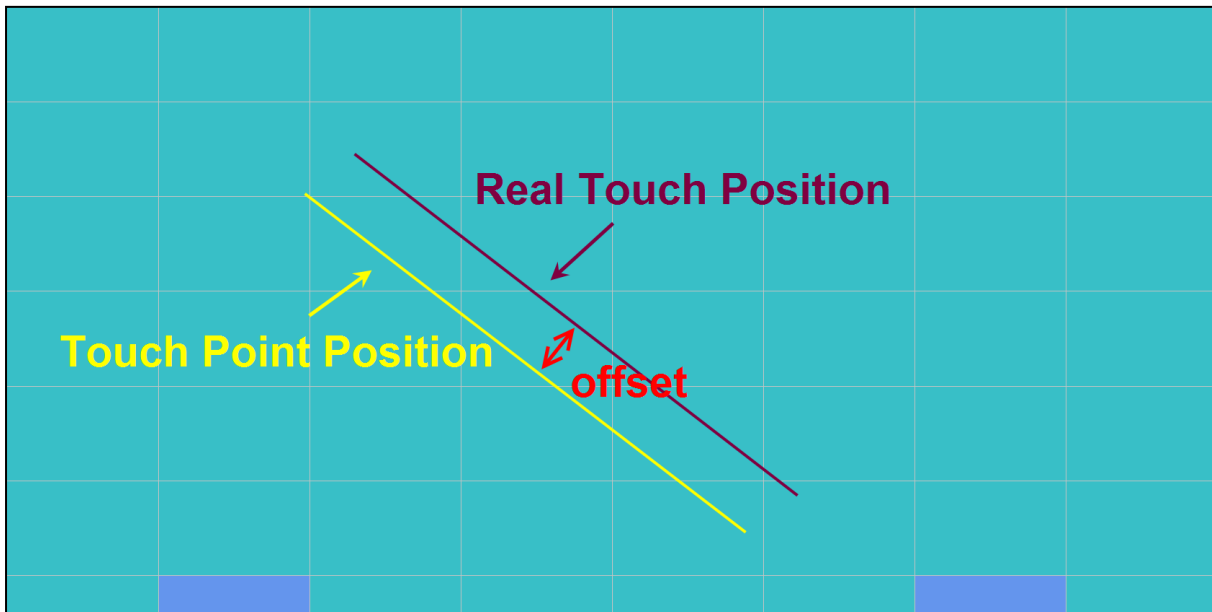
Accuracy problem means there's always an offset between Real Touch Position and Touch Point Position.

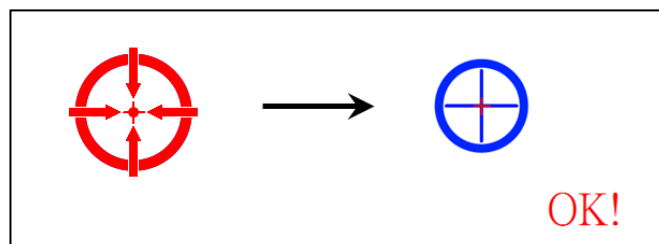
After AutoTune the touch panel will use the default accuracy parameter if it has accuracy problem, please follow below steps to calibrate accuracy.

1-1. Click "4 Points Calibration" button.

1-2. Touch the target till 100% than release.

(top-left / top-right / bottom-left / bottom-right)

- Touch panel with screen is required, there's no way to calibrate accuracy without the display.
- Please touch the target with great precision, if not, the accuracy may get worse.

(you can also click "Reset To Default" to recover the default parameter.)

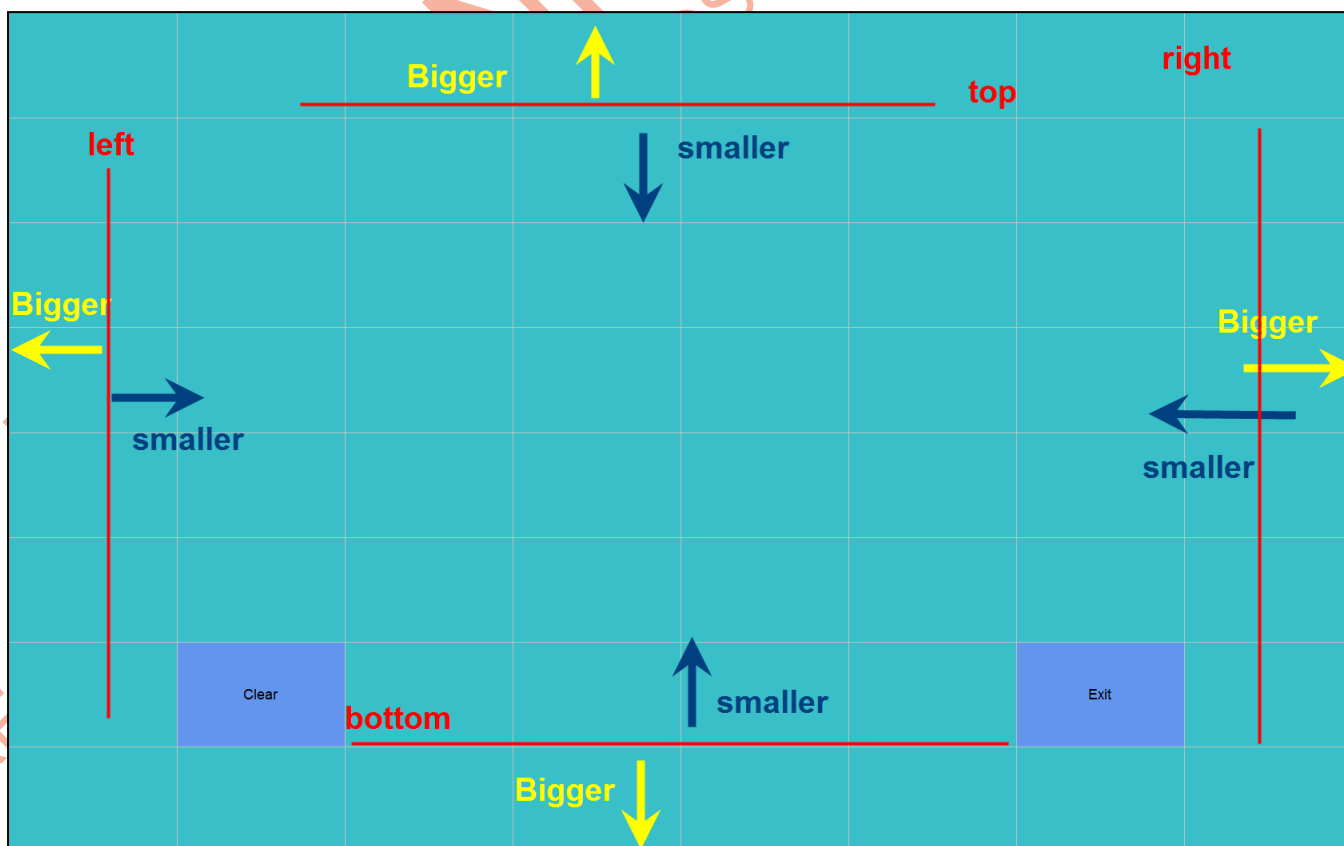
Below picture shows how to adjust. The bigger the compensation is, touch point will close to the edge more.

Over compensation may cause edge accuracy problem.

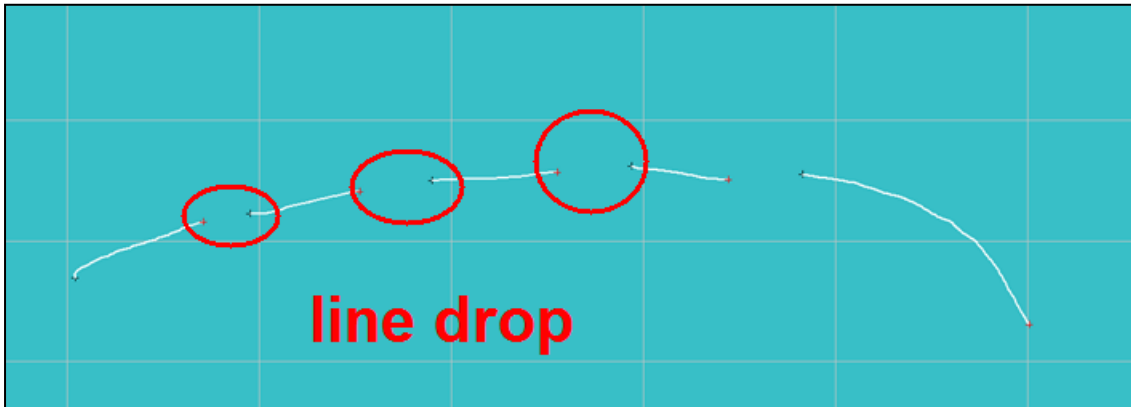
Touch panel doesn't response well to the real touch. (ex: line drop / touch no response)

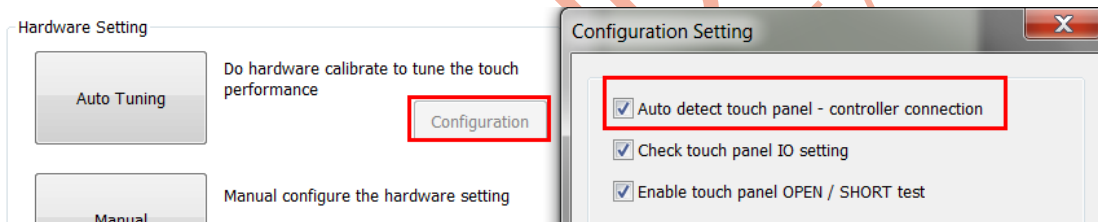
a. Use auto setting (Enable below config)
